Perfection Home Inspections
1042 E. Fairbrook Circle
Mesa, AZ 85203
480-833-9330
perfectionhomeinspections.com

Client Information: Record Number 2688

123 S. Big Street

Inspected 3/23/05 3:00pm

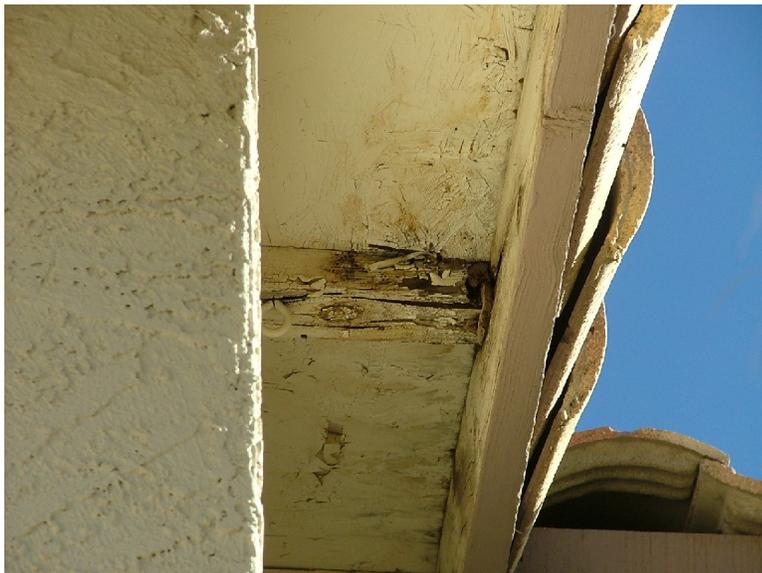
Soffit\Eaves\Fascia - Wood

The soffit and fascia at the front of the front porch has wood rot and what looks like wood eating fungus. Some wood rot in the soffit neat the master bedroom window facing the front. Recommend solving what caused this problem then have a qualified contractor evaluate and make all necessary repairs. See picture

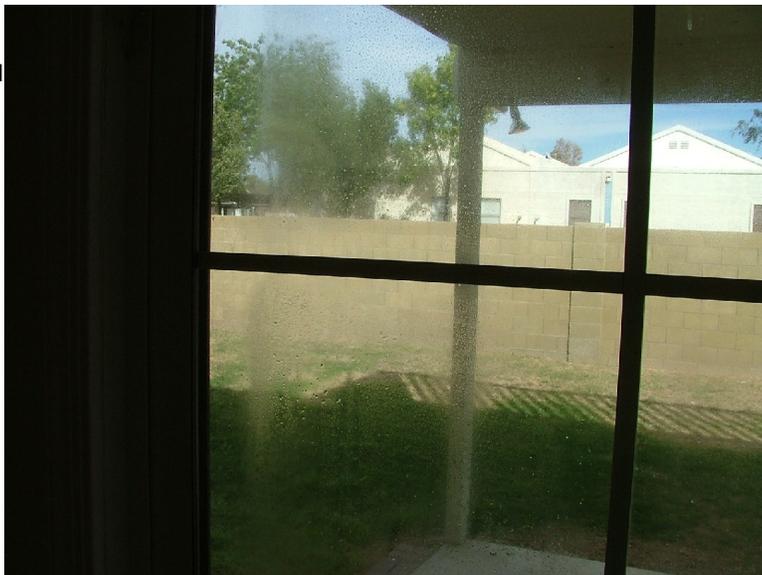
Patio Doors - Sliding, Screen Door Missing

Screen door missing. The window pane has lost its seal. Recommend a qualified contractor evaluate and make all necessary repairs.

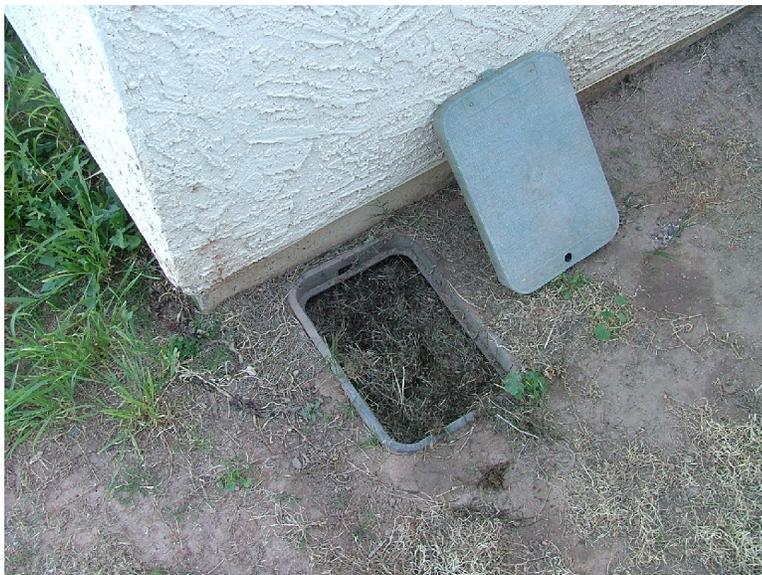
Service/Repair **Sprinkler System - Vacuum Breaker**

The sprinkler box in the back is full of debris. Recommend cleaning debris out of box and checking valves.

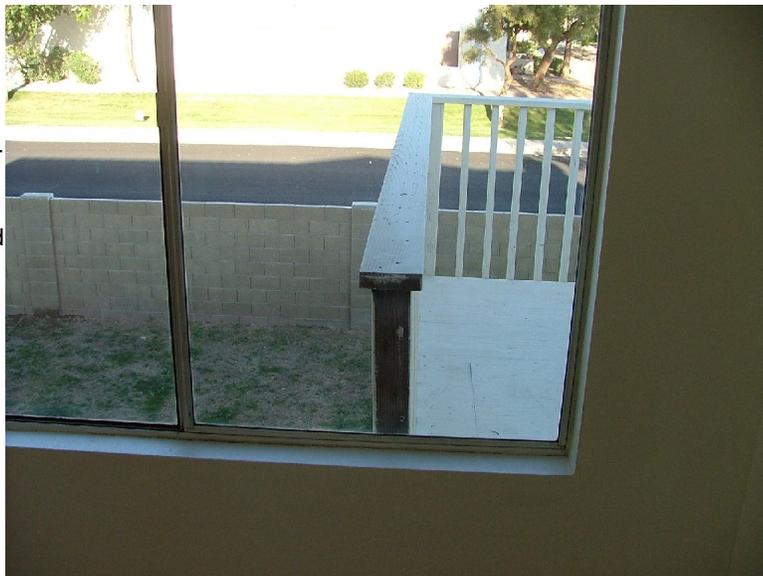
Recommend 4 inch maximum spacing for all railings to protect small children from falling. This may have been acceptable at the time it was build.

Recommend checking for building permits for the balcony in the back. There does not appear to be proper footing under the columns supporting the balcony.

Recommend a qualified contractor evaluate and make all necessary repairs. See picture

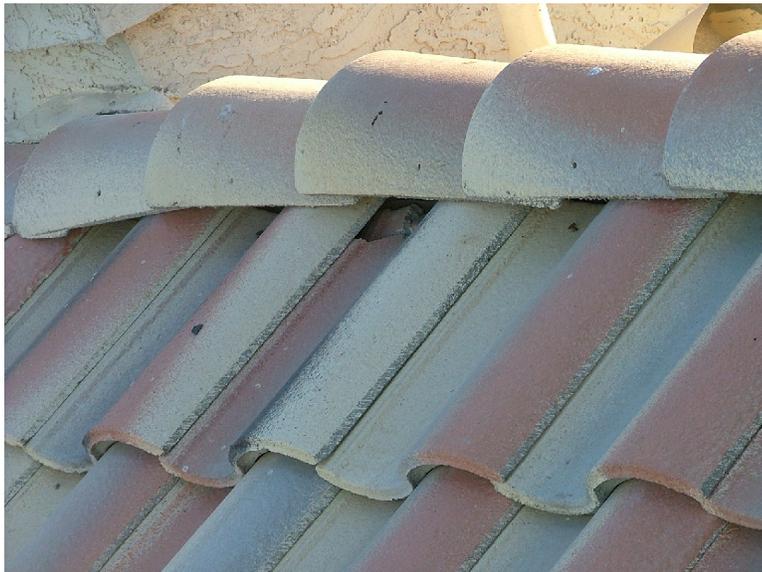
Roof Covering - Tile

One cracked roof tile in the front next to a plumbing vent pipe.
One cracked roof tile in the back on row 8 in 3 feet from the south side.
Recommend a qualified licensed roofing contractor evaluate and make all necessary repairs. See sample picture

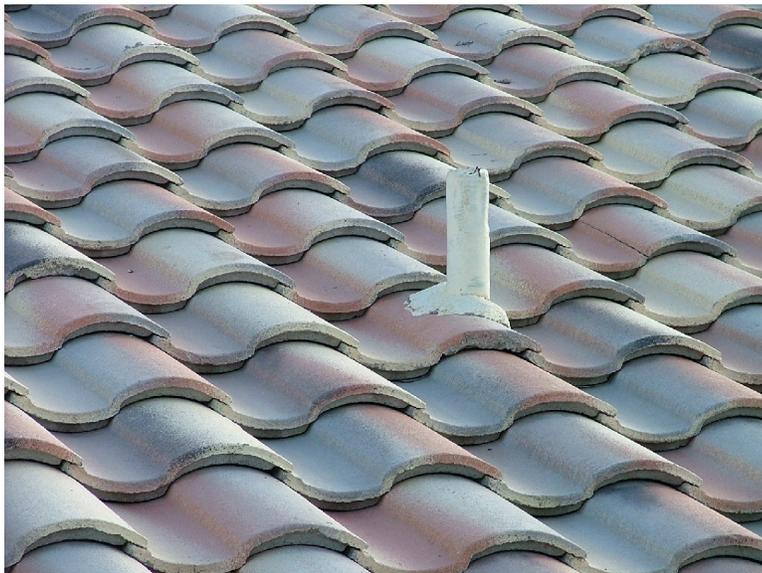
Flashing - Lead

Two flashings on the north side and one on the south side do not extend out of the tiles below and appear to have been installed wrong. Recommend a qualified roofing contractor evaluate and make all necessary repairs. See picture

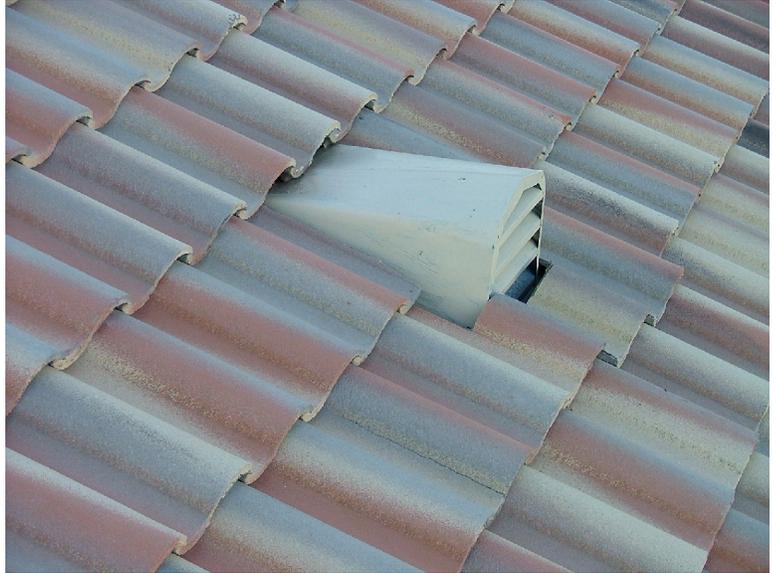
Other Roof Penetrations - Roof Vents

Two roof vent in the back have been installed with the flashing under the tiles this allows water to flow under the roof tile and may have caused the leak in the master bedroom ceiling. Recommend a qualified roofing contractor evaluate and make all necessary repairs.

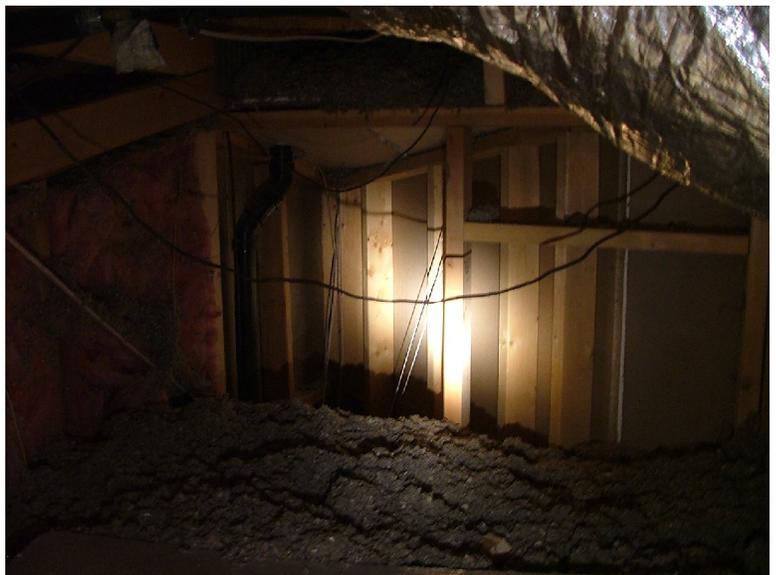
Attic Insulation Thickness - 7.5 inches

Insulation missing on some interior walls in attic. See picture
Recommend properly installing attic wall insulation. See picture

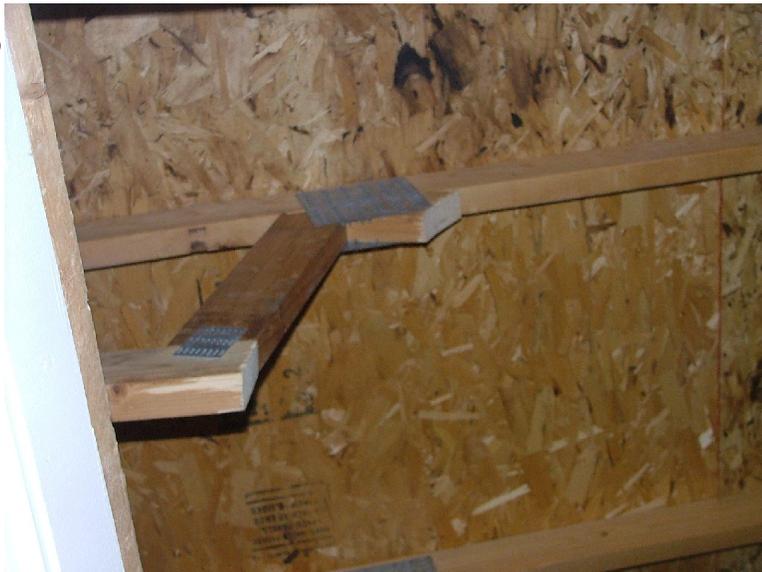
Attic Structural Framing Type - Trusses

On truss in the attic directly above the attic hatch in the master closet has been cut and two structural wood members have been removed from this truss. See picture
 Recommend a qualified framing contractor evaluate and make all necessary repairs.

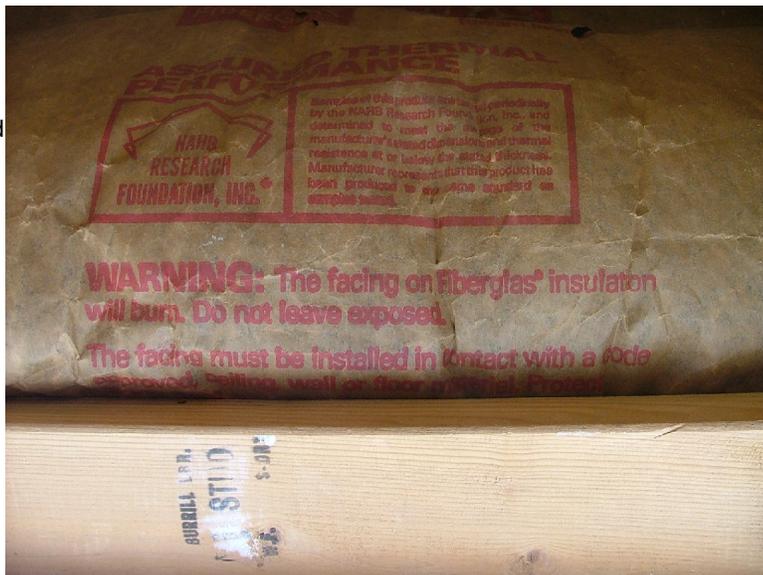
Insulation & Vapor Retarder - Found in Unfinished Area

The insulation vapor barrier is stamped DO NOT LEAVE EXPOSED FIRE HAZARD. Most of the insulation vapor barrier above the garage appears to be exposed.
Recommend a qualified contractor evaluate and make all necessary repairs.

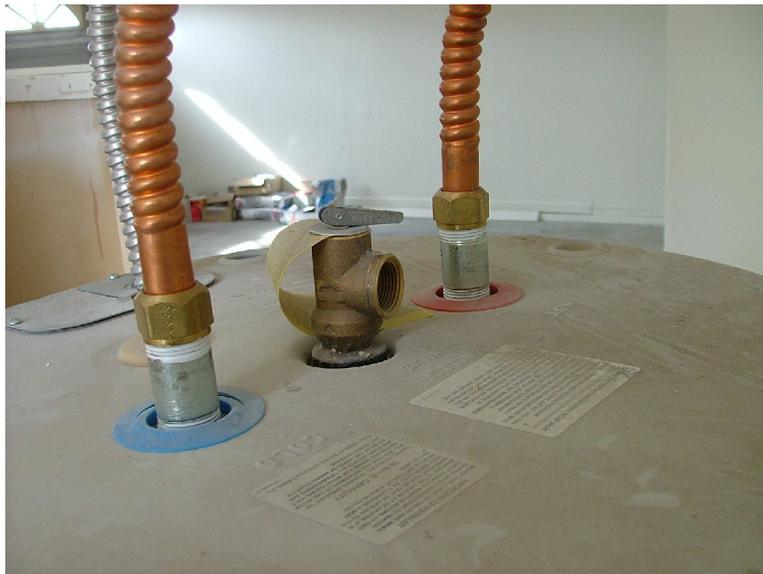
Temp. Pres Relief Valve and Pipe - Ext Pipe Missing

Recommend the water heater temperature and pressure relief valve have a pipe extended from the valve 6 to 12 inches above the floor. The current arrangement is a safety issue. Scalding steam can unexpectedly blow out the end of this pipe and the chances of someone getting burned increases the further the pipe gets above the ground.

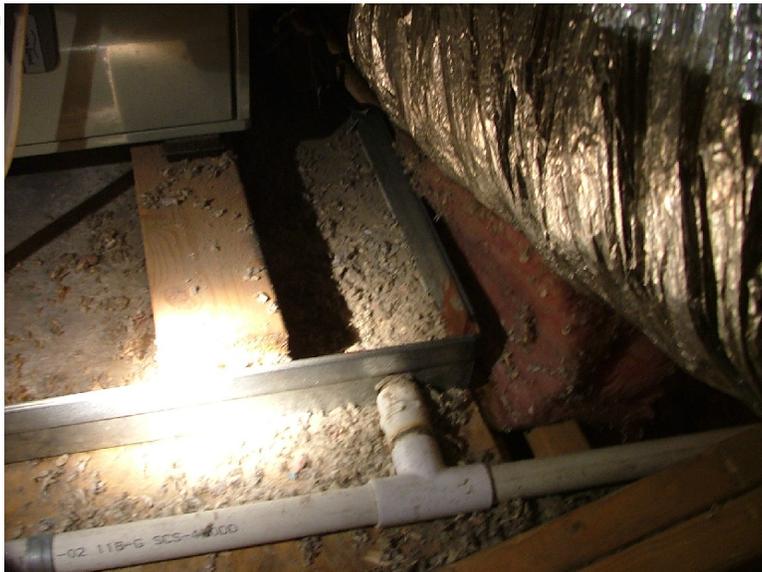
Debris in the air handler overflow pan. This can block the emergency overflow pipe and cause the pan to overflow in the attic. Recommend cleaning overflow pan and making sure emergency over flow pipe is not clogged. See picture
When the out side temperature falls below 65 degrees within 24 hours of the inspection the AC systems is not tested to avoid damage to the compressor.
Dust and other contaminants usually find there way into all heating and cooling systems. For all used homes to help protect your health and for better air quality I recommend before moving in or soon thereafter a thorough cleaning of the entire heating and cooling duct system by a qualified professional.

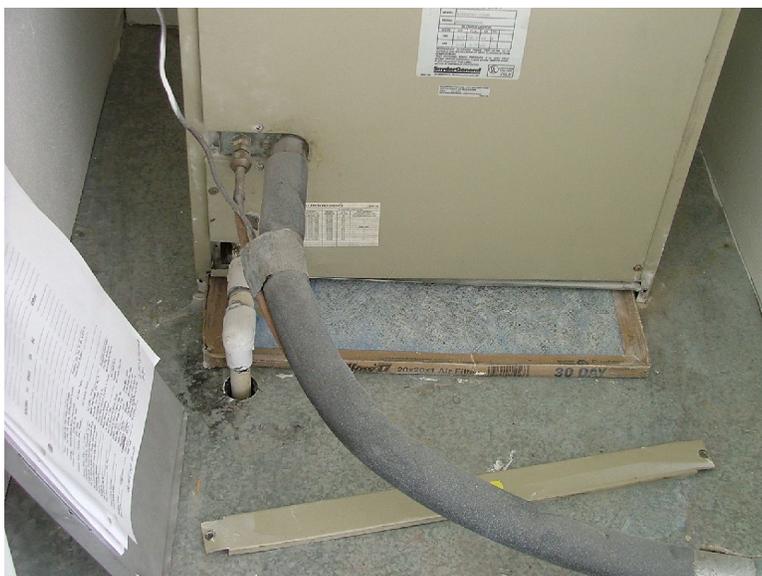
Air Filters and Dampers - Clogged

The air filter in the garage is blocked by the condensate line. This keep the filter from being removed or installed. The current filter is clogged.

Recommend replacing dirty air conditioner filter. When air filters get dirty the chances of dirt and other contaminants getting by the filter and into the duct system increases. Recommend replacing or cleaning air filters once a month and sooner when needed. Dirty filters also put a strain on the heating and cooling system and may cause the system to malfunction.

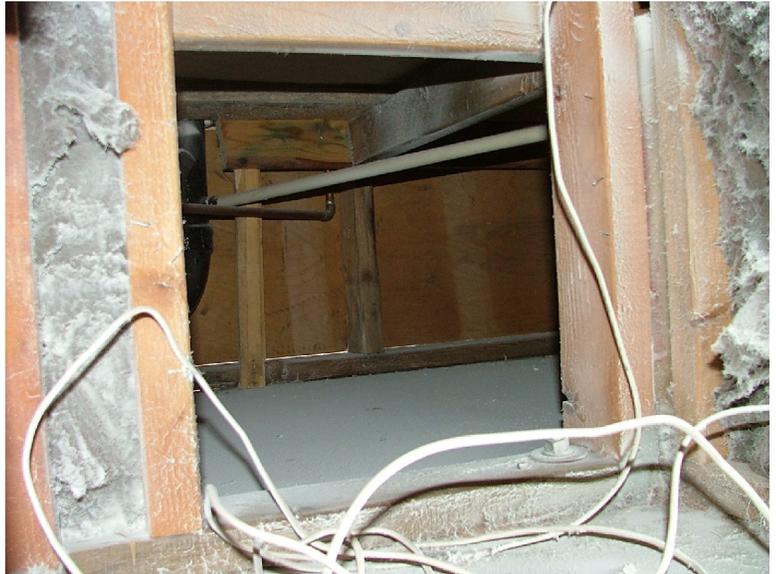
Air Handler(s) - In Garage

The air handler in the garage has a patch on the all from the garage to the air return and the patch allows air from the garage to be sucked into the return air box. This will allow carbon monoxide from the garage to enter the AC duct system. Recommend a qualified heating and air conditioning contractor evaluate and make all necessary repairs.

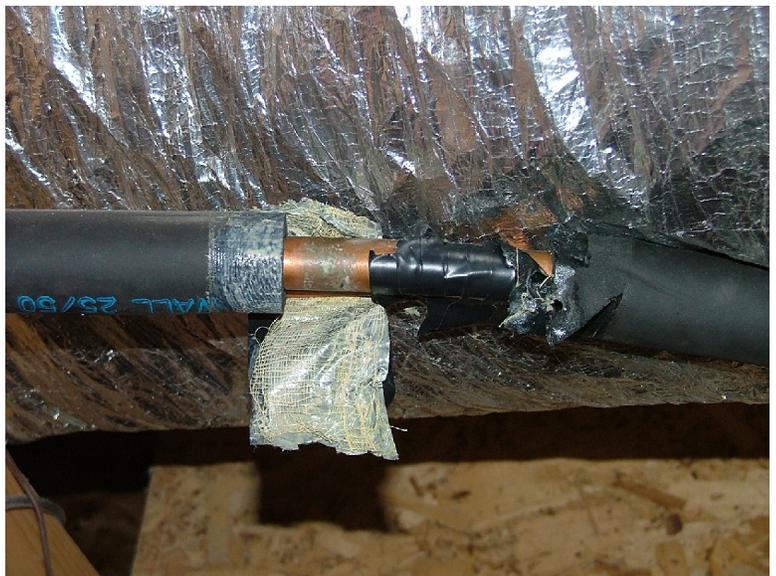
Cooling Lines - Missing At Attic Unit

Insulation missing on cooling line in attic. Recommend installing missing insulation to avoid condensation leaks form this cold pipe. See picture

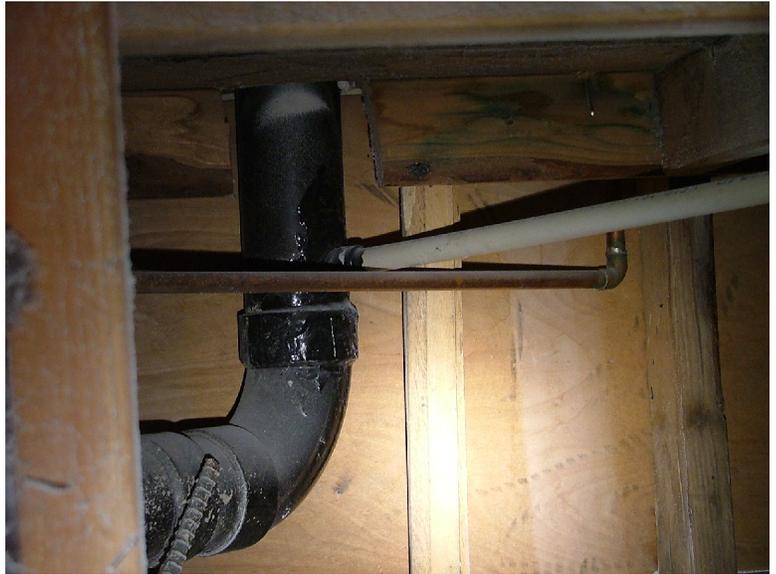
The condensate line from the garage air handler has been installed in the side of a 4 inch drain line in the wall. There is no p-trap on this line so this will allow sewer gas to be drawn into the house through the AC system. This type of condition has led to the spread of the Legionnaires disease. Recommend extending the condensate line directly to an exterior location and properly repairing hole in 4 inch drain line. See picture

In the attic both the normal condensate line and the emergency condensate line have been attached together so if one line clogs they both clog. Recommend a separate line for each.

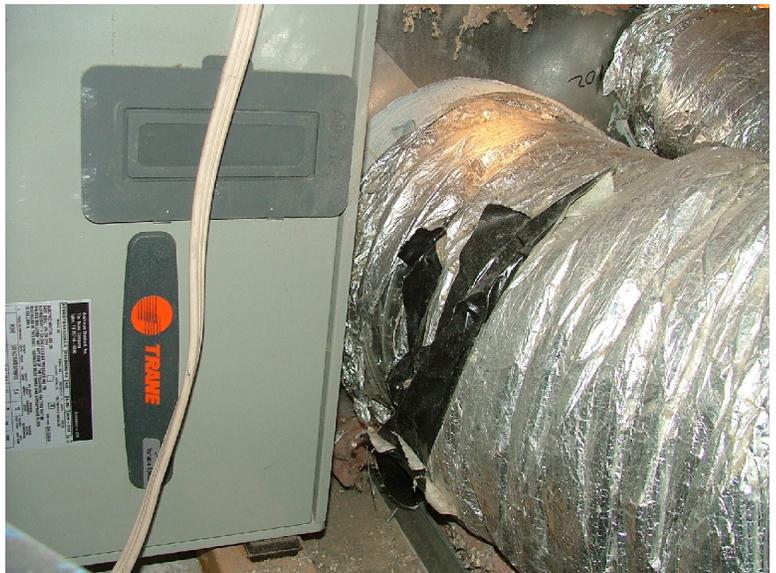
Distribution System For Central AC and Heating Sys - Insul. Flex Duct

The outer plaster vapor barrier of the flexible AC duct is missing next to the air handler in the attic. This allows the hot attic air to warm the cool duct air before it reaches the living space below. When the hot attic air hits the cold AC duct condensation may be formed creating a moisture problem in the attic. Recommend a qualified AC contractor evaluate this situation and make all necessary repairs.

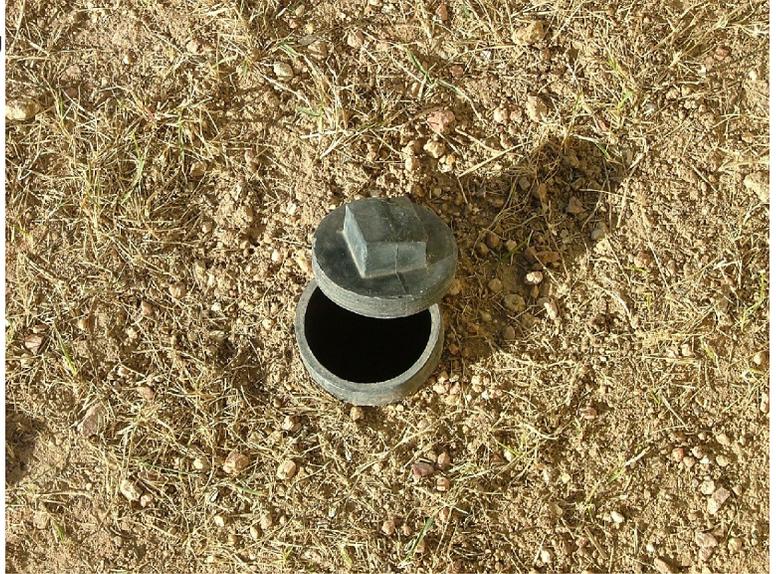
PLUMBING - General Comment

Plumbing clean out pipe missing proper cover. This may allow debris to enter the pipe and clog the drain line. Recommend a qualified plumbing contractor evaluate and make all needed repairs.

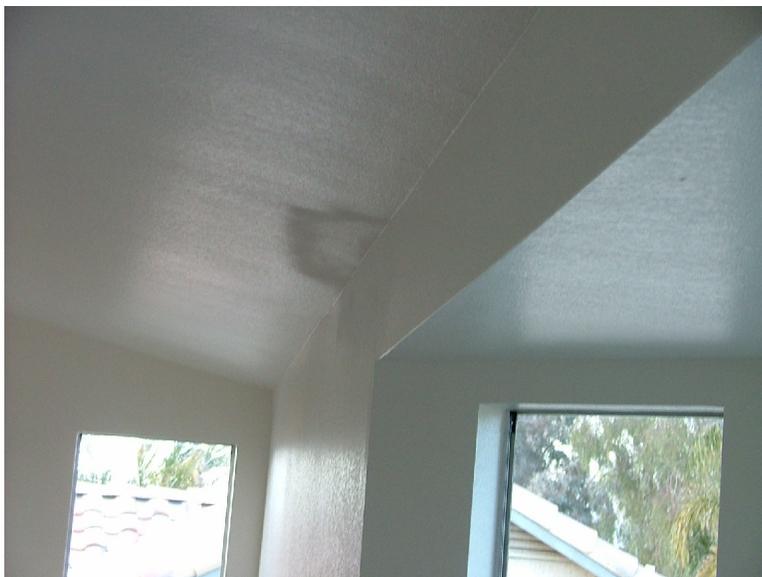
Walls and Ceiling - Drywall

There has been a patch on the north sided of the bay windows and the ceiling above has been painted with a flat paint that does not match the rest of the room. There may have been a roof leak here. Recommend monitoring this area when it rains. This area is directly below a roof vent that is not properly flashed. Recommend asking seller if the problem has been properly repaired and if not have a qualified contractor evaluate and make all necessary repairs.
